T2 Laboratories Explosion Damage Assessment

Presenter: Ben Harrison, P.E., ABS Consulting, 14607 San Pedro Suite 215, San Antonio, TX, 78232, phone (210) 495-5195, fax (210) 495-5134, bharrison@absconsulting.com

Co-Author: Robert Hall, P.E., U.S. Chemical Safety Board, 2175 K. Street, NW, Suite 400, Washington, DC 20037-180, (202) 261-7600, rob.hall@csb.gov

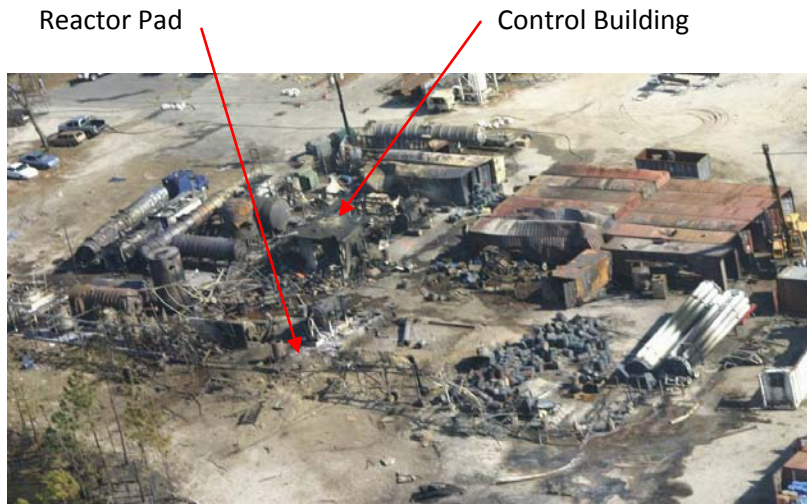
Figure 1. T2 Laboratories Post Incident Aerial Photograph ^[1]

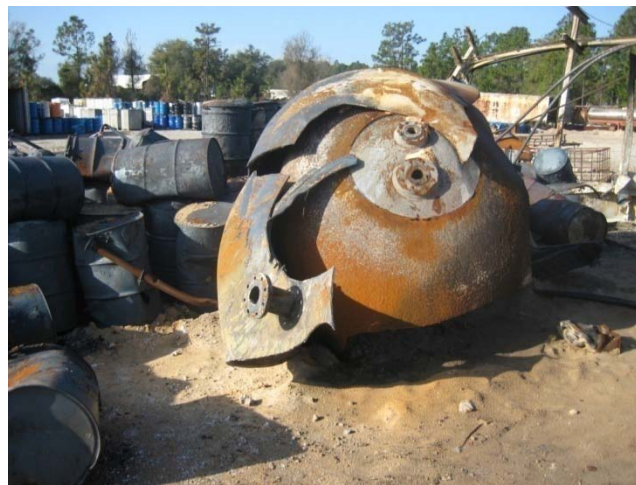
The source of the explosion was established as a catastrophic failure of the reactor vessel, see Figure 2. The explosion threw many pieces of the vessel as missiles and generated a blast wave that swept across the surrounding area causing significant structural damage to several buildings off-site.

Figure 2. T2 Laboratories Reactor Head ^[1]

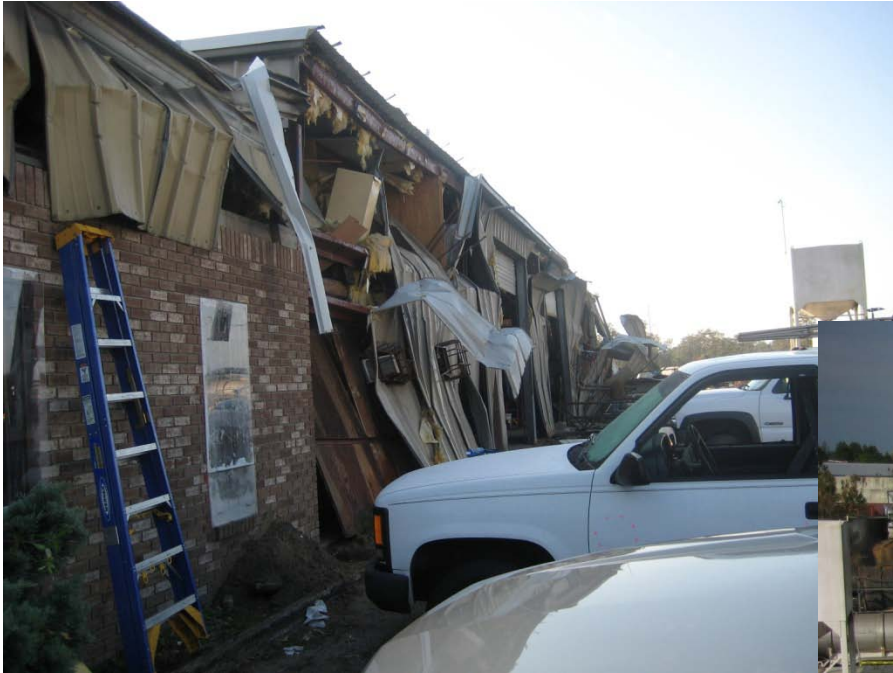
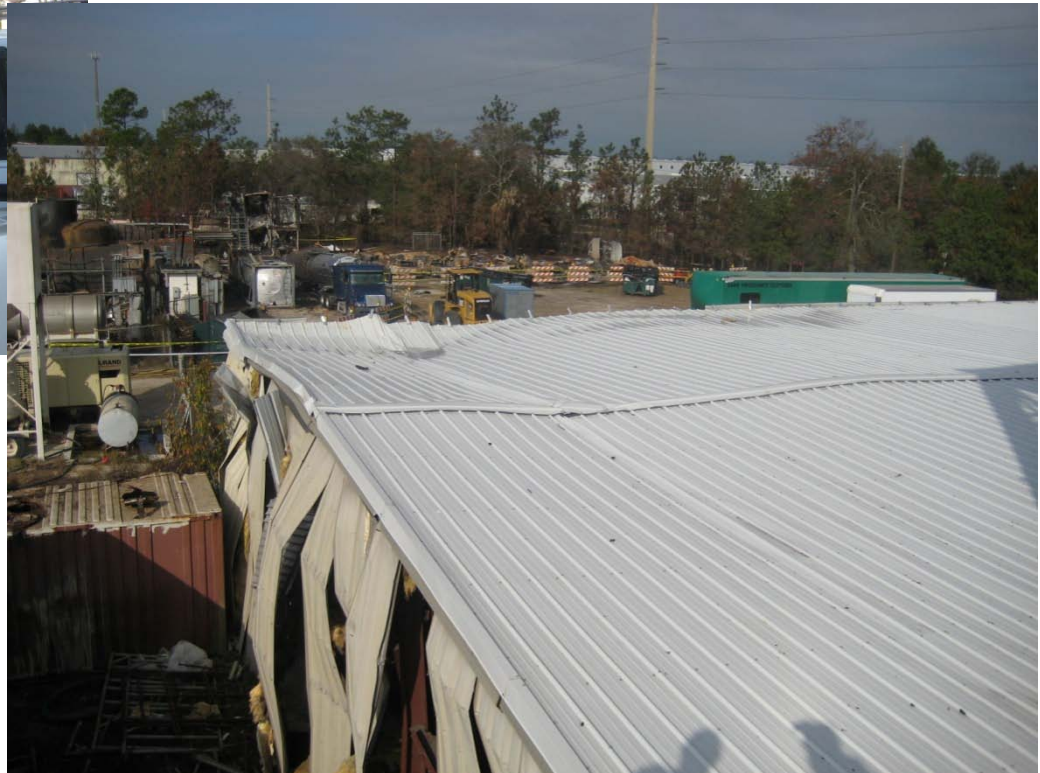
Building 300 – K25

- ERASDAC BDL 3
- SBEDS Heavy Damage

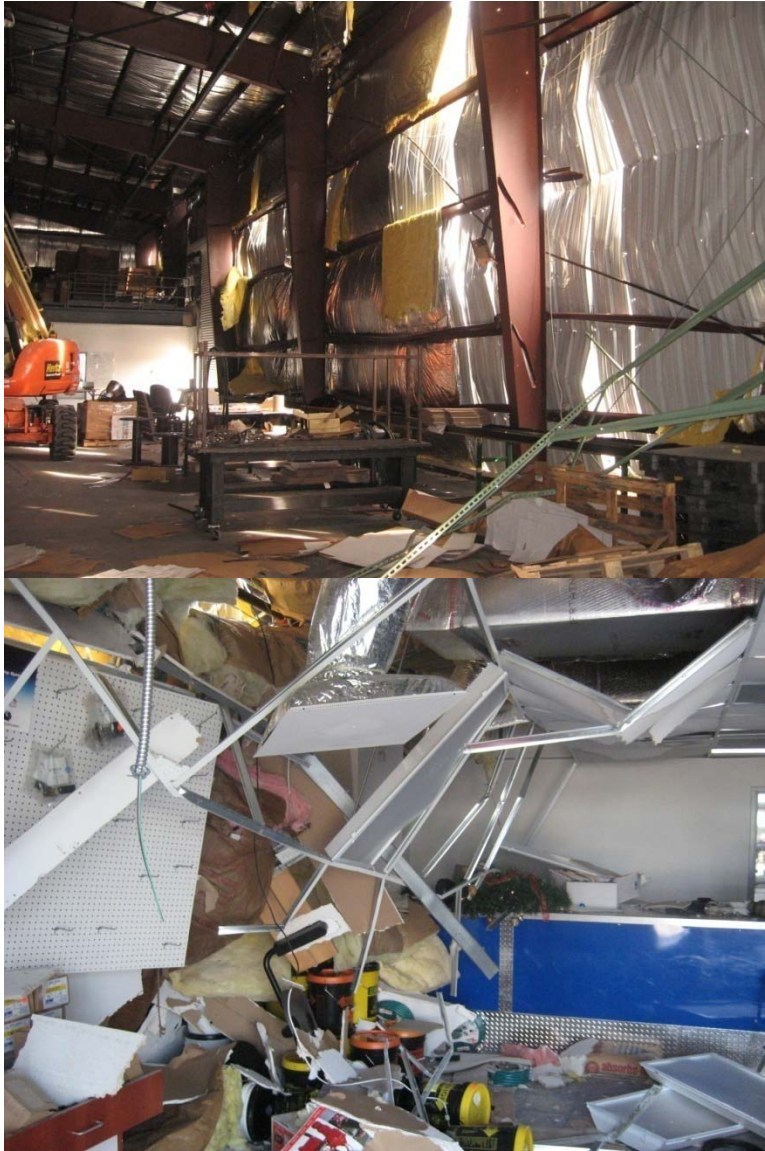
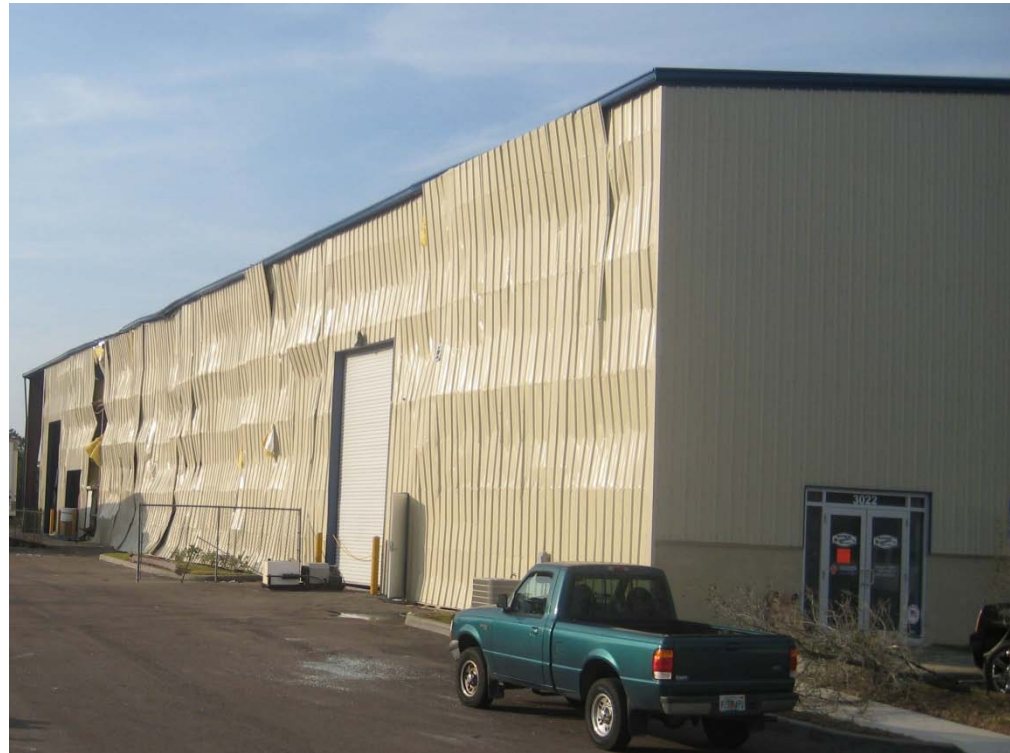
Building 200 – K50

the potential exists to cause structural damage well beyond K40 separation. Two large pre-engineered warehouses (Buildings 101 and 200) located at K50 were condemned as a result of the explosion.

- ERASDAC BDL 2A
- SBEDS Unreparable

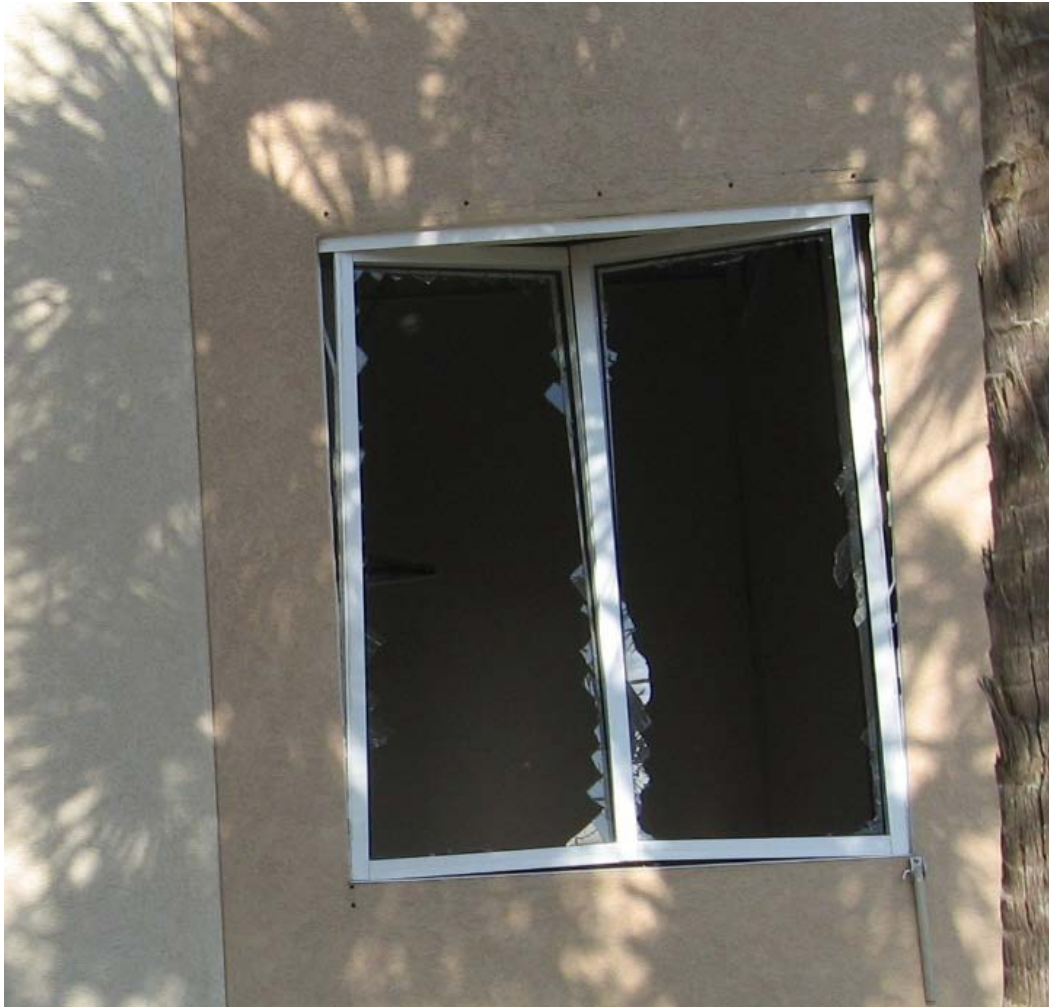
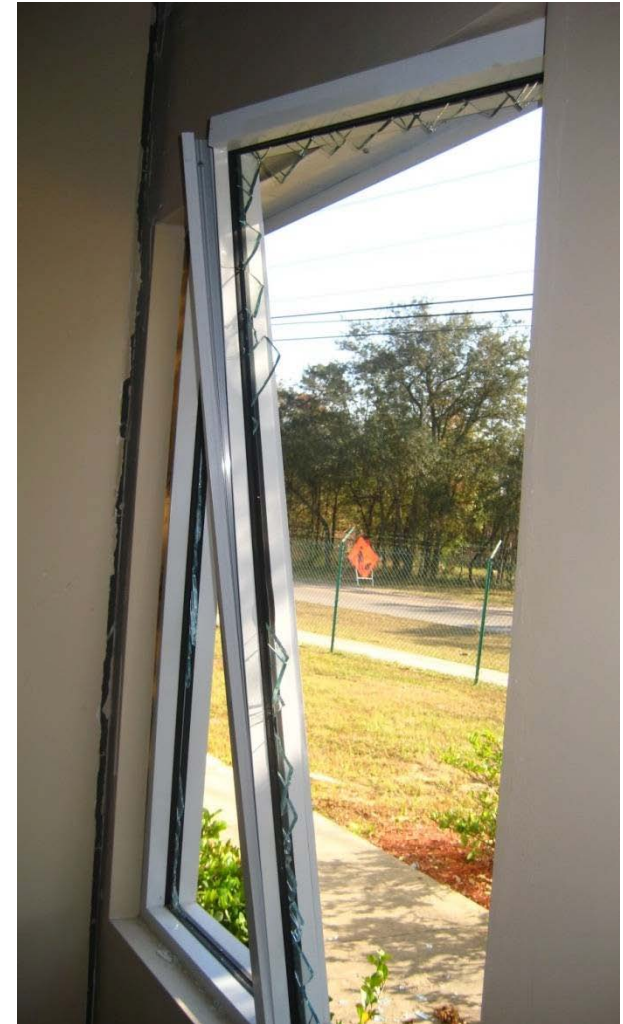
Building 101 – K50

Hazard Level 5

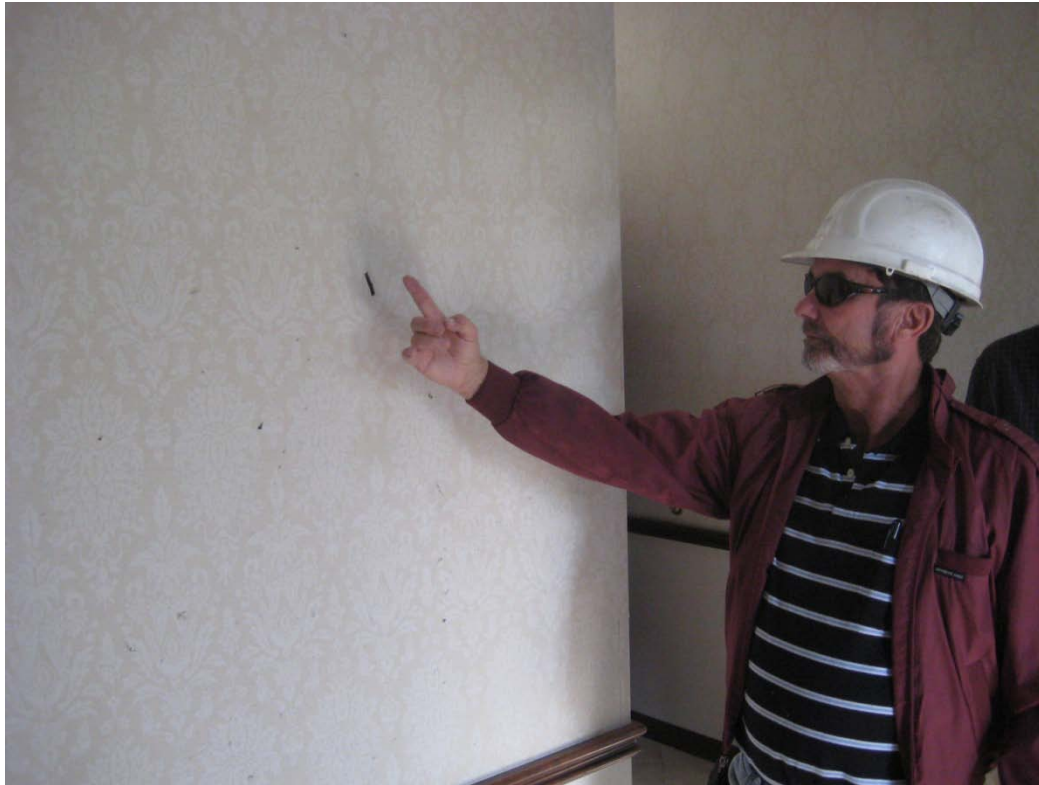
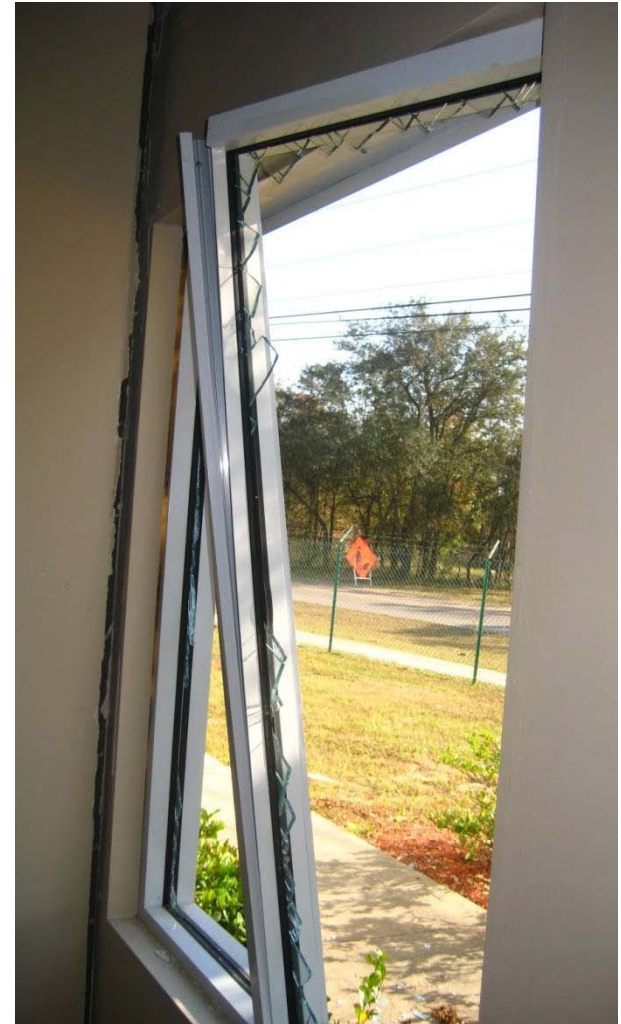
Building 101 – K50

Hazard Level 5

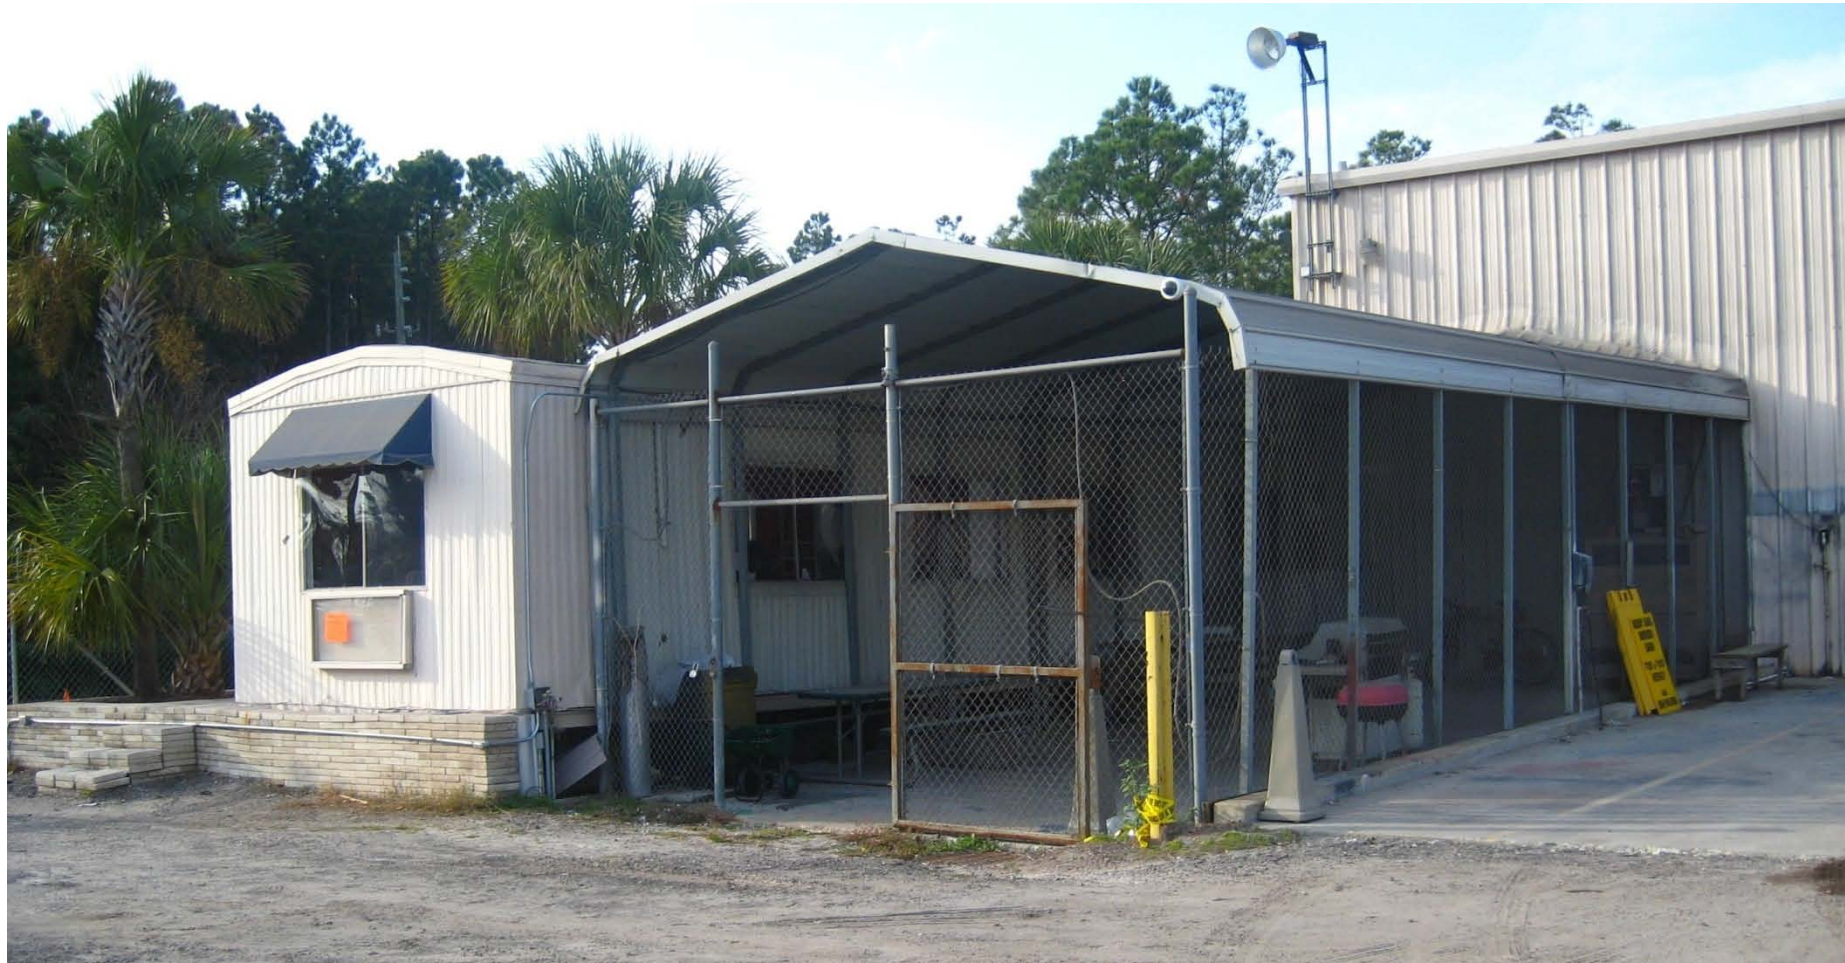
Building 501 – K75

Hazard Level 4
